TOXING® OF THE SHEAR-BAND

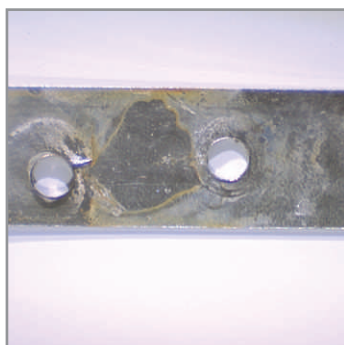
spot welded

The traditional shear band fabrication entails spot welding of clamps to the shear band. Heat created during the welding process actually burns the stainless steel. The composition of the stainless steel is attacked and intercrystalline corrosion can result at the welding points.

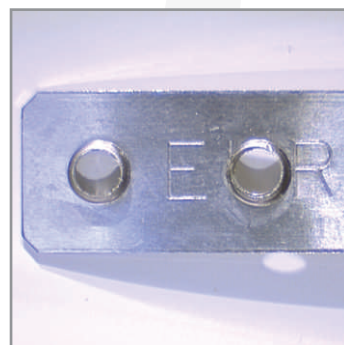
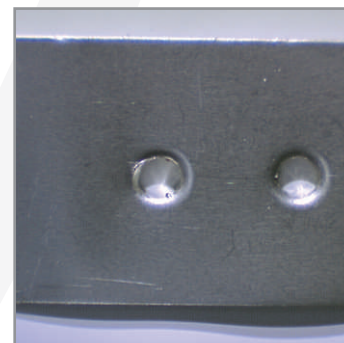
toxed

The shear band on the new Mücher, Canada Plus Coupling incorporates the latest in stainless steel fastening techniques: TOX®-Technology (no spot welds). The negative aspects associated with spot welding are eliminated in this advance process, yet the bond meets or exceeds all relevant tensile strength and shear requirements.
